**ICSOT India:
Coastal & Inland Shipping,**

ANALYSIS OF ANTIFOULING PAINTS USING DRUM-TEST APPARATUS

M Joshi, S.C. Misra and U.S. Ramesh, Indian Maritime University (Visakhapatnam Campus), Visakhapatnam, India
A. Mukherjee, Gayatri Vidya Parishad College of Engineering, Visakhapatnam, India

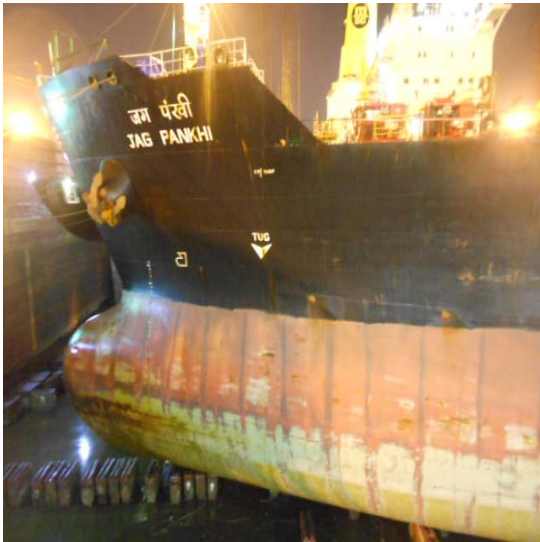
Figure 1: Photographs of a vessel taken on arrival at dry-dock indicating areas on antifouling paint deterioration

Figure 1&2 are photographs of a tanker initially coated with a self-polishing antifouling coating that has just arrived for a mandatory dry-dock after a gap of five years, showing areas on the hull that have been depleted of antifouling paint. Figure 3 depicts the computed wall shear stresses of a similar tanker using commercially available CFD software (FLUENT). Comparison of fouling data from a large number of photographs and the computed wall stresses indicates that regions where the latter are high are highly prone to fouling which indicates that uneven polishing rates take place around the vessels hull which strongly depends on the vessel profile, speed and draft. This gives an important clue that AF painting schemes must take in to account the non-uniform hydrodynamic forces that exist along the vessel's hull which would be best served by obtaining a correlation between polishing rates and shear stresses in a laboratory set up. Once polishing rates are known, the AF film thickness could then be computed for the corresponding wall shear stress. In order to find a correlation between the hydrodynamic forces and polishing rates, a "Drum Test Apparatus" has been fabricated.

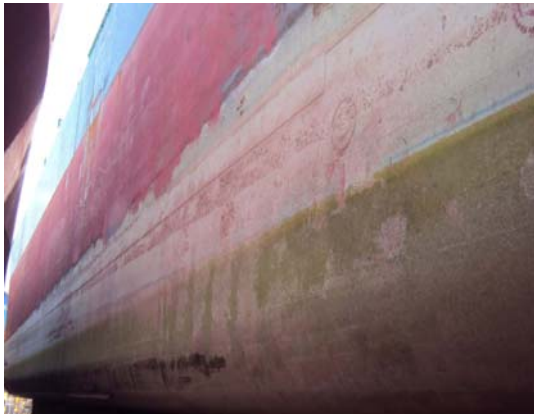
Figure 2: Photographs of a vessel taken on arrival at dry-dock indicating areas on antifouling paint deterioration

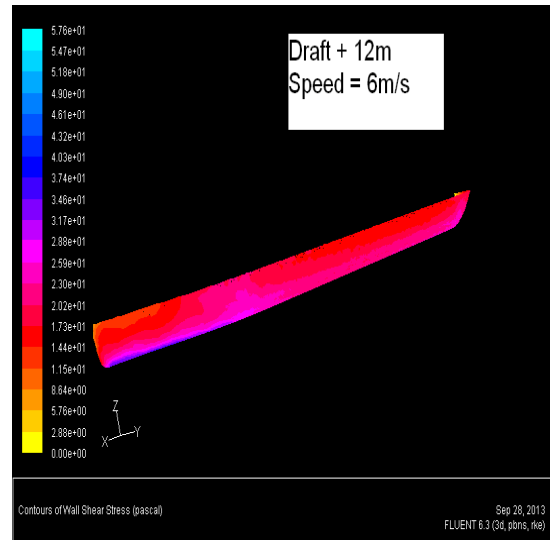
Figure3: Wall shear stresses of a tanker at a draft of 12m and speed of 6m/s

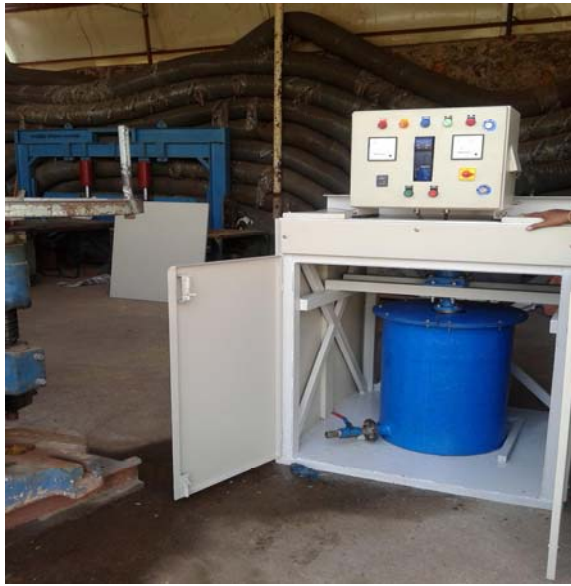
Figure 5: View of Drum Test Apparatus

cylinder is 600 mm in diameter and is stationary. The gap within the inner and outer cylinders is filled with sea water. Plates coated with various antifouling paints are affixed on the inner cylinder and the inner cylinder is rotated at a known fixed speed for a predetermined time. Figure 5 shows a photograph of the drum test apparatus while in figure 6, shows the central rotor with one of the attached plate that is coated with the antifouling paint that is to be tested. A total of six such plates can be attached to the central drum. The drum is then rotated at a fixed RPM. The residual thickness of the antifouling coating is then measured at regular intervals. This procedure is repeated for various speeds.

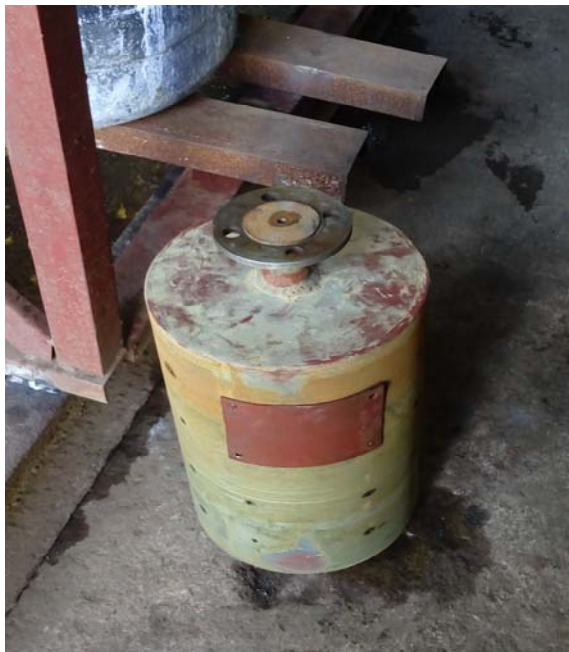
Figure 6: Central rotor of the drum test apparatus with the attached test plate
